F100 ENGINE DIAGNOSTIC SYSTEM STATUS TO DATE

James A. Boyless
Wright-Patterson Air Force Base

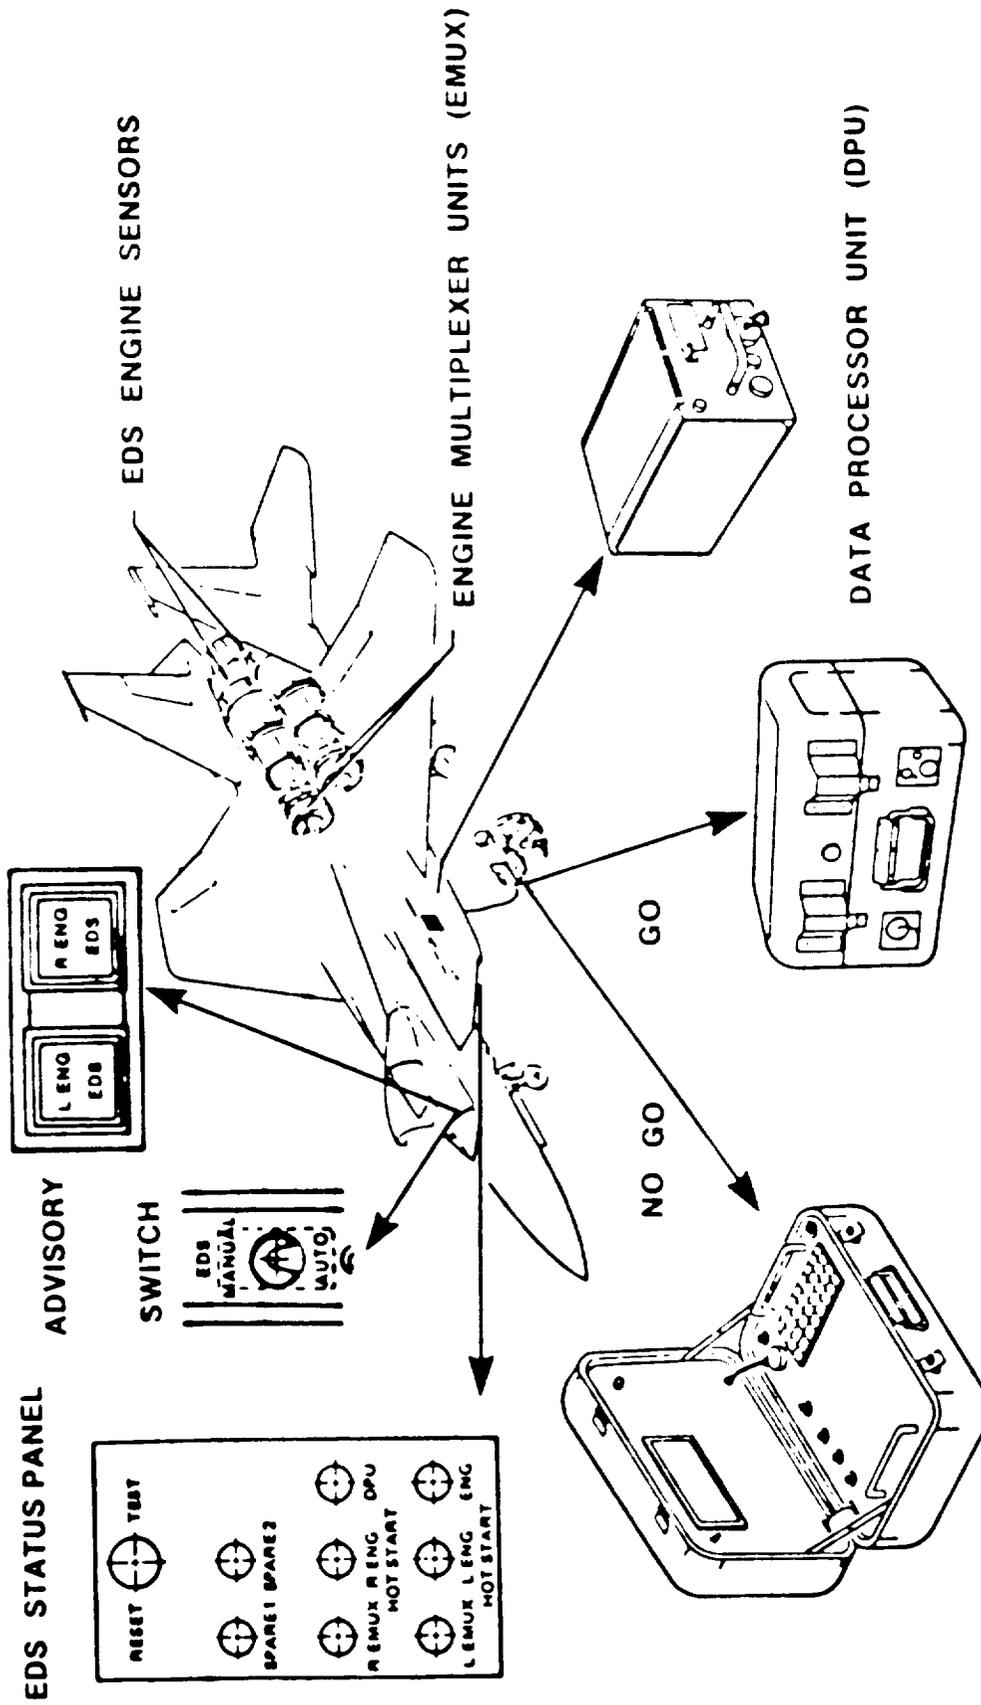
FIGURE 1

SYSTEM DESCRIPTION

DIAGNOSTIC DISPLAY UNIT (DDU) DATA COLLECTION UNIT (DCU) DATA PROCESSOR UNIT (DPU)

The F100 engine is well suited for the complex task of engine diagnostics. It is a modular engine designed for operational readiness and maintainability. It is also complex and requires knowledgeable maintenance personnel for repair. To ably assist the maintenance personnel, the F100 EDS went through an extensive review of Failure Modes and Effects Analysis (FEMA) and cost effective analysis. Thirty eight engine and airframe parameters were included in the EDS. Once these parameters were selected, hardware was developed to monitor the required information. The F100 EDS has eight primary elements that visually present cues of engine status, and/or provides a means to collect and diagnose engine anomalies. These elements shown in Figure 1 are:

receptacle. These components are also depicted in Figure 1. The DPU can, on command, store a data record by means of the pilot option switch located to the left of the pilot. In addition, a cockpit warning lights indicate Fan Turbine Inlet Temperature (FTIT) Overtemperature or excessive temperature occurrences.

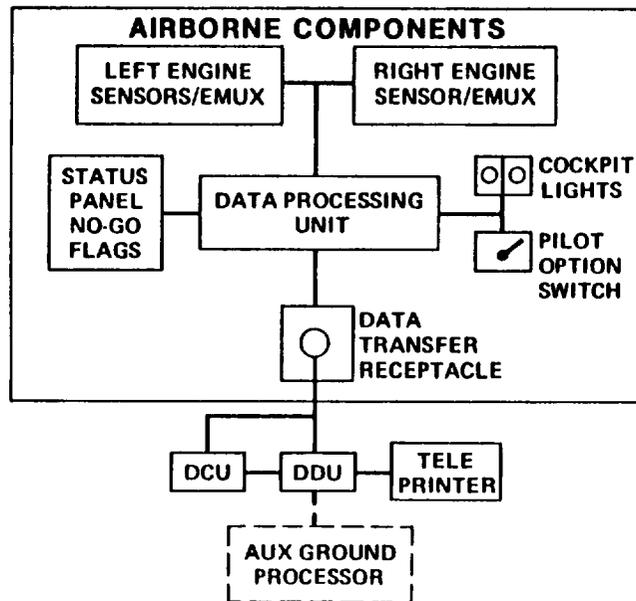
FIGURE 2

EDS DATA COLLECTION

A schematic view of how EDS data was collected is shown in Figure 2. The components shown detail the units involved in the airborne and ground portions of the system description.

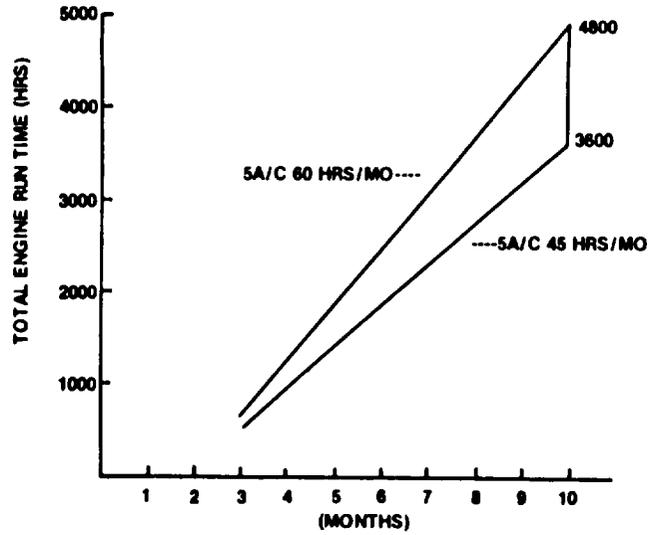
FIGURE 6

EDS EXPECTED FLIGHT EVAL ENGINE OPERATING HOURS

4. To gather the data, there were five F-15 aircraft and eleven engines specially modified for the test (See Figure 5). These aircraft were to average between 45 and 60 engine operating hours per month (See Figure 6).

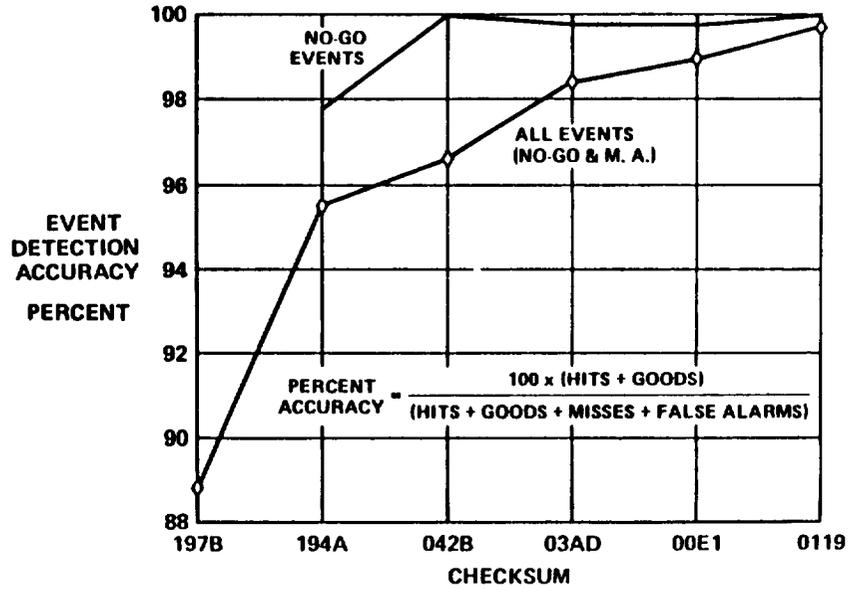
FIGURE 9

EVENT DETECTION ACCURACY

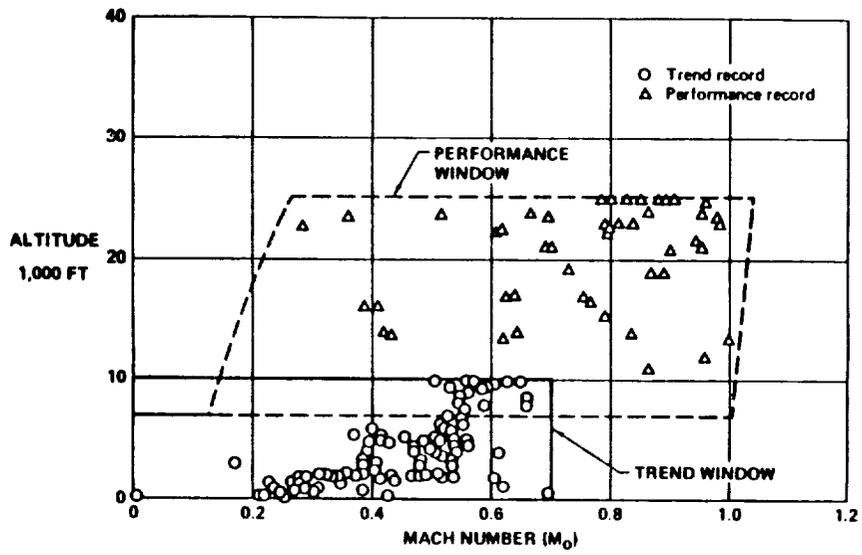
FIGURE 11

TREND/PERFORMANCE RECORD SUMMARY

7. Finally, trend and performance data was collected. Accumulated data indicates that 183 data points were captured EDS and the resulting analysis revealed that 74% of the data points lay in the lower PLA range (See Figure 11). This range, 30^o-40^o, is the area of idle reset area where the augmentor is wide open. The conditions for data to accurately reflect trending and performance required a stabilization time of 180 seconds and was often reached in a landing
